ENVIRONMENTAL PERMIT NO. EP-071/2000/B

**LAMMA POWER STATION EXTENSION
ENVIRONMENTAL MONITORING & AUDIT PROGRAMME
AT CONSTRUCTION PHASE**

Report Title	Monthly EM&A Report (December 2001)
Date	14 January 2002
Certified by

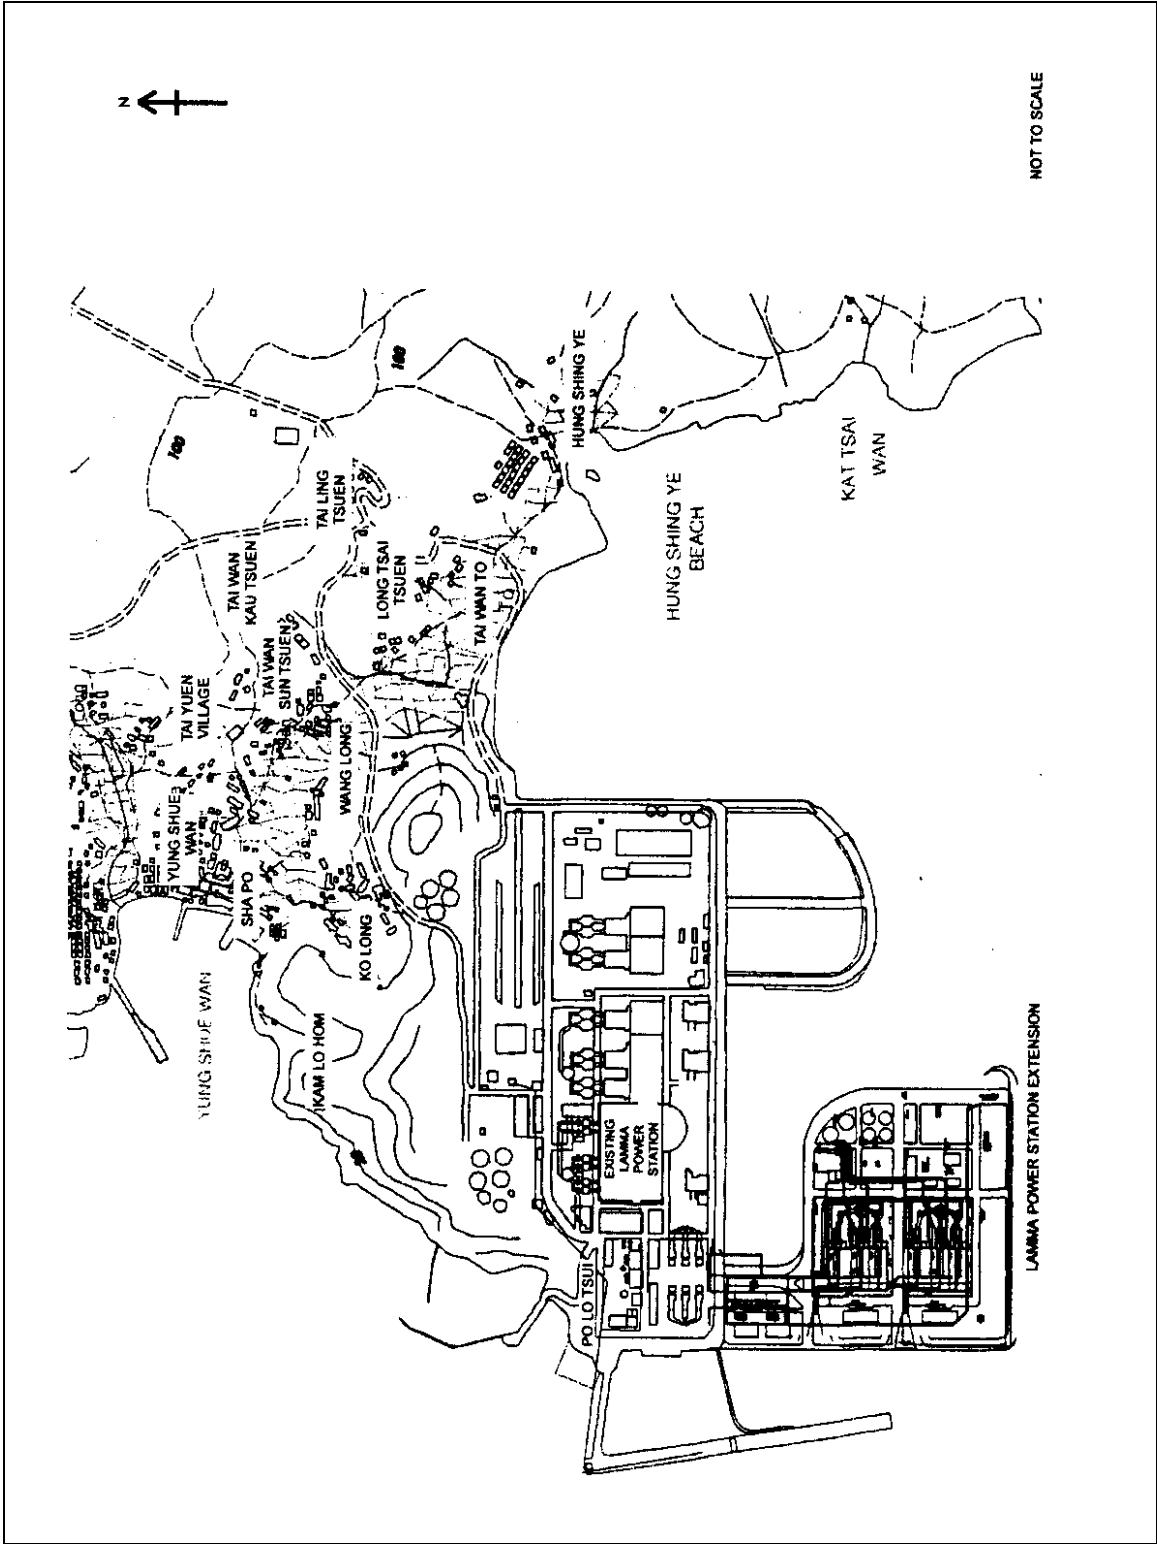
Figure 1.1 Layout of Work Site

Construction activities undertaken during the reporting month were placing of drainage layer and seawall construction. No sand filling was undertaken in the month. A Layout Plan for the Project is shown in Figure 1.1.

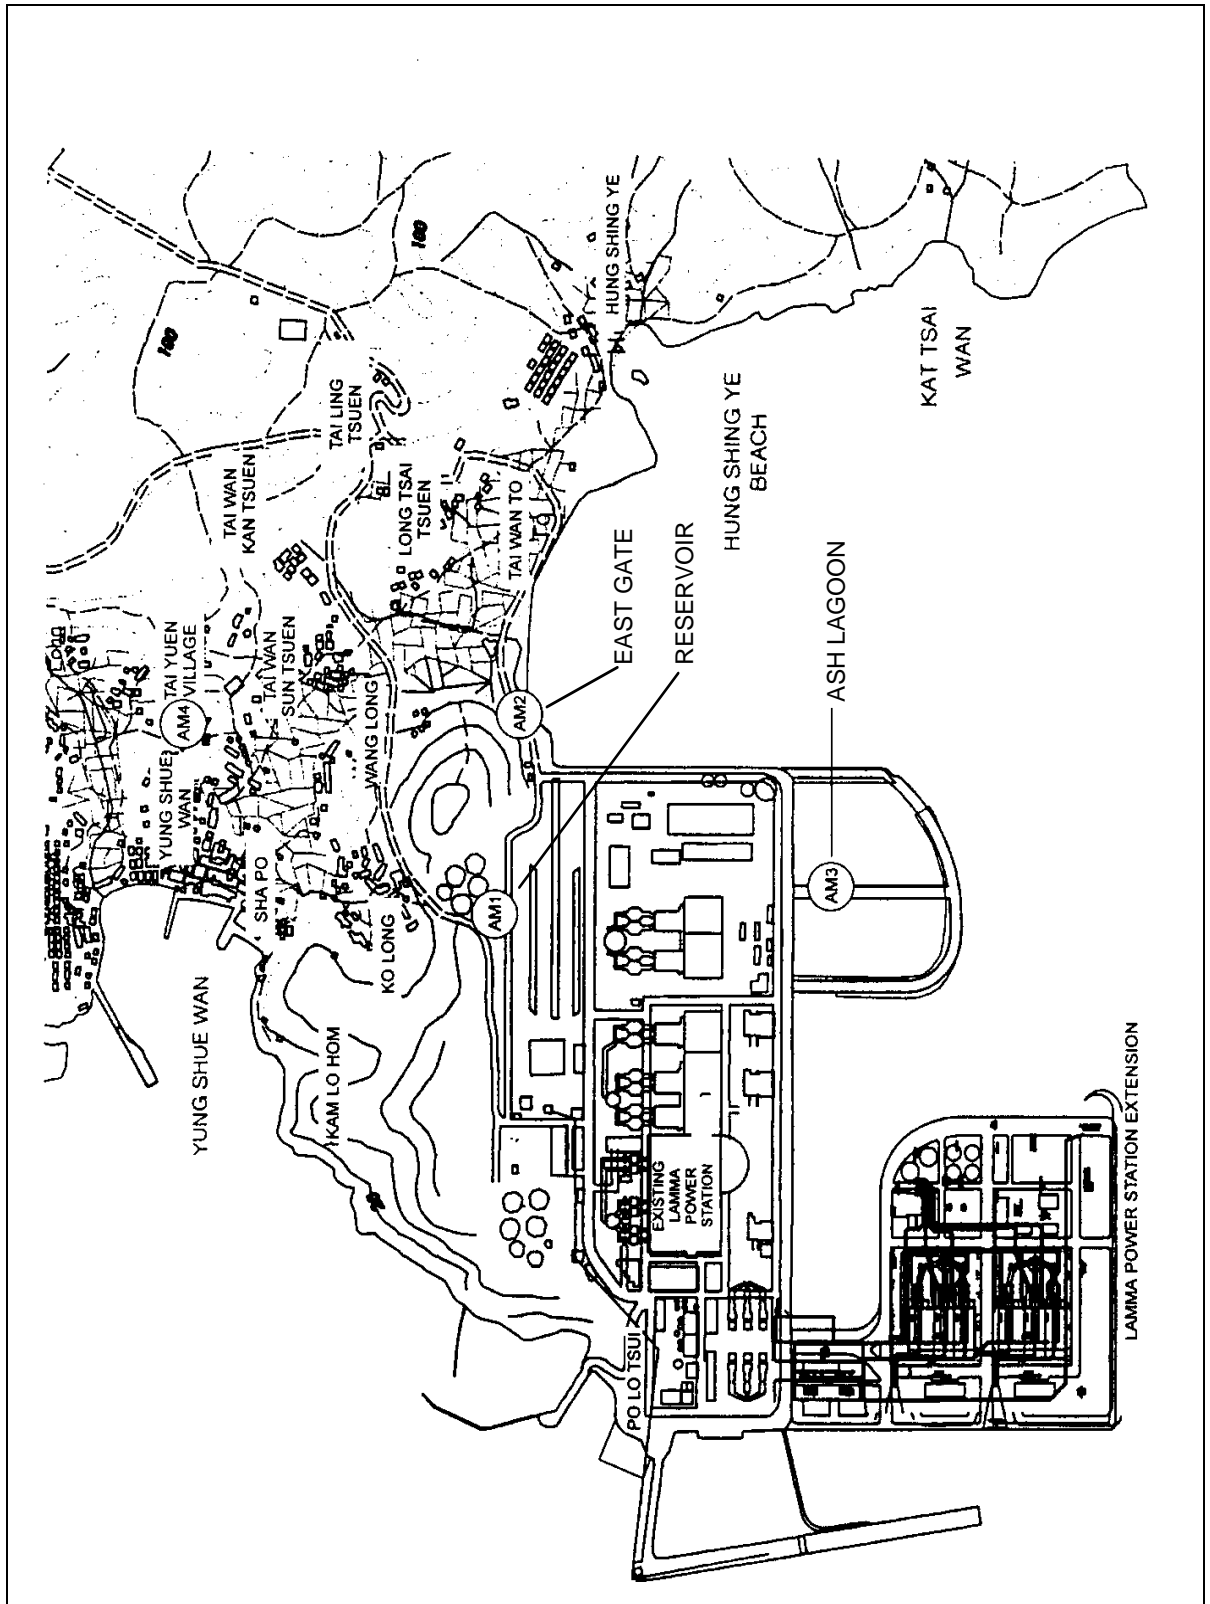
Figure 2.1 Location of Air Quality Monitoring Stations

Three dust monitoring locations were selected for 1-hour TSP sampling (AM1, AM2 & AM3) while four monitoring locations were selected for 24-hour TSP sampling (AM1, AM2, AM3 and AM4). Table 2.1 tabulates the monitoring stations. The locations of the monitoring stations are shown in Figure 2.1.

Location I.D.	Description
AM1	Reservoir
AM2	East Gate
AM3	Ash Lagoon
AM4	Tai Yuen Village

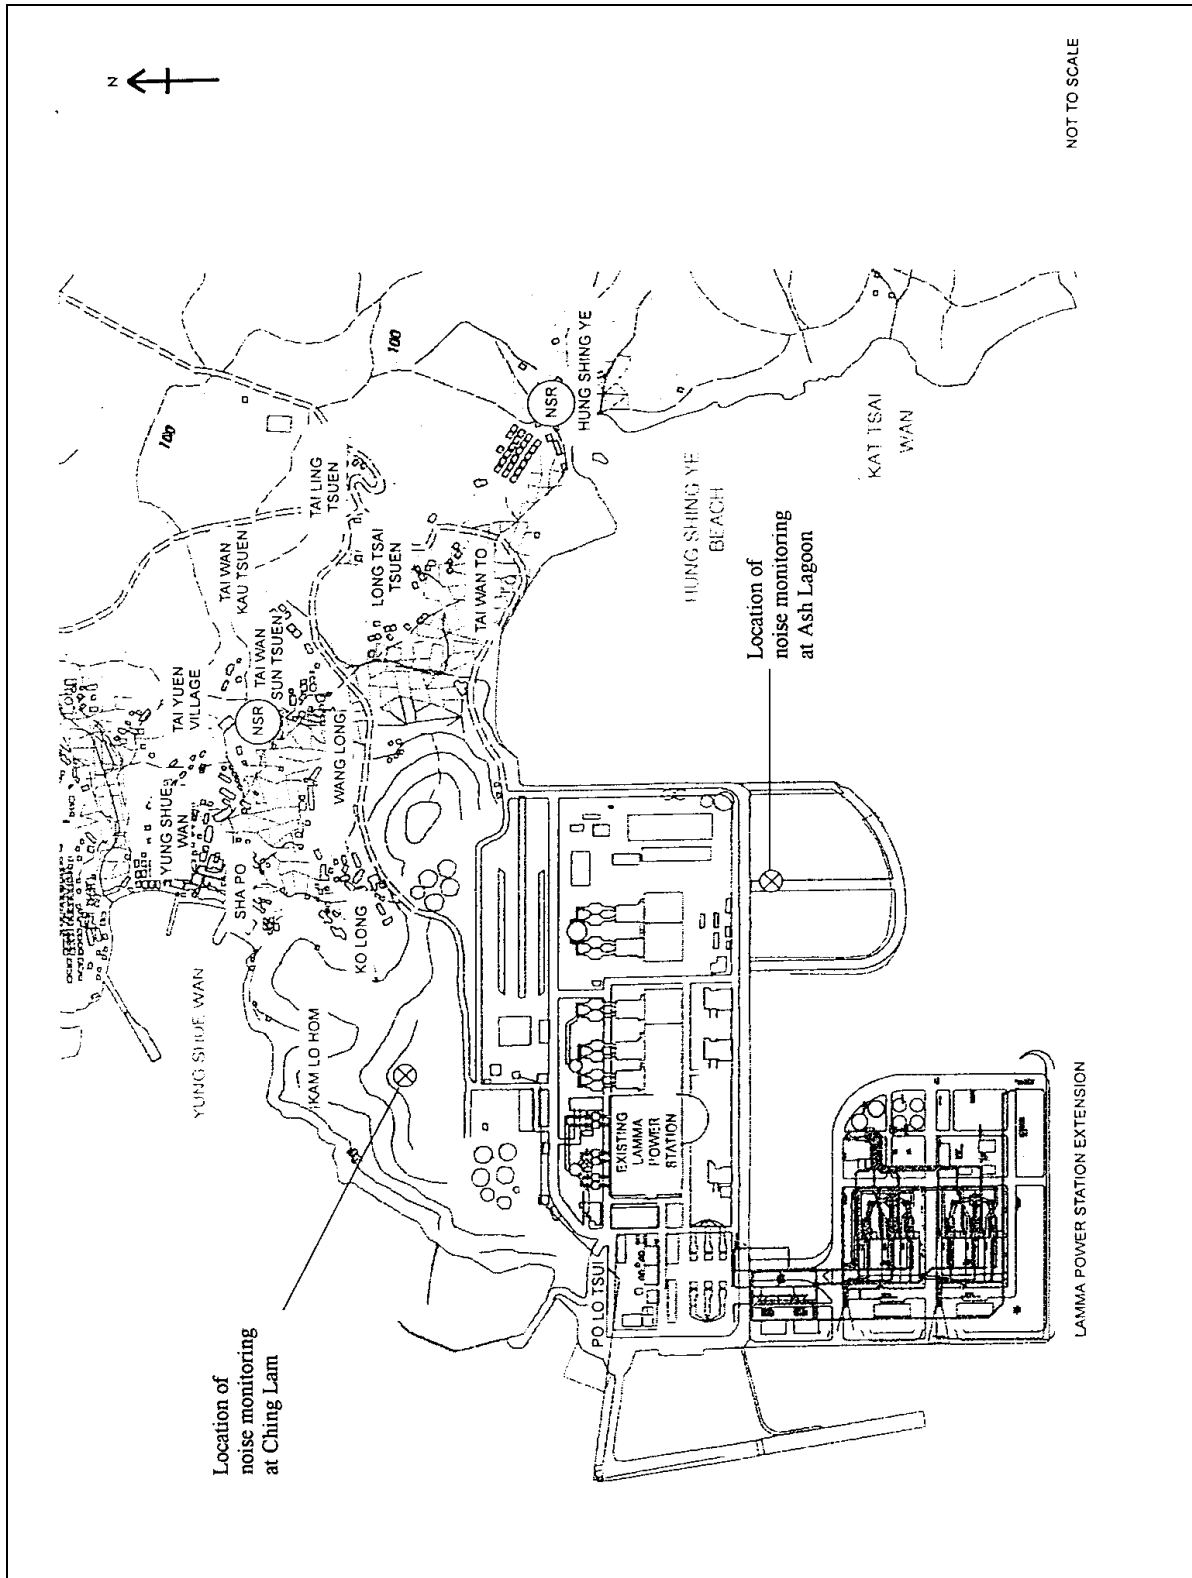
Figure 3.1 Location of Noise Monitoring Stations

In accordance with the EM&A manual, the identified noise monitoring locations are listed in Table 3.1 and shown in Figure 3.1.

Purpose of noise monitoring	Monitoring Location
Lamma Extension	Ash Lagoon
Lamma Extension	Ching Lam

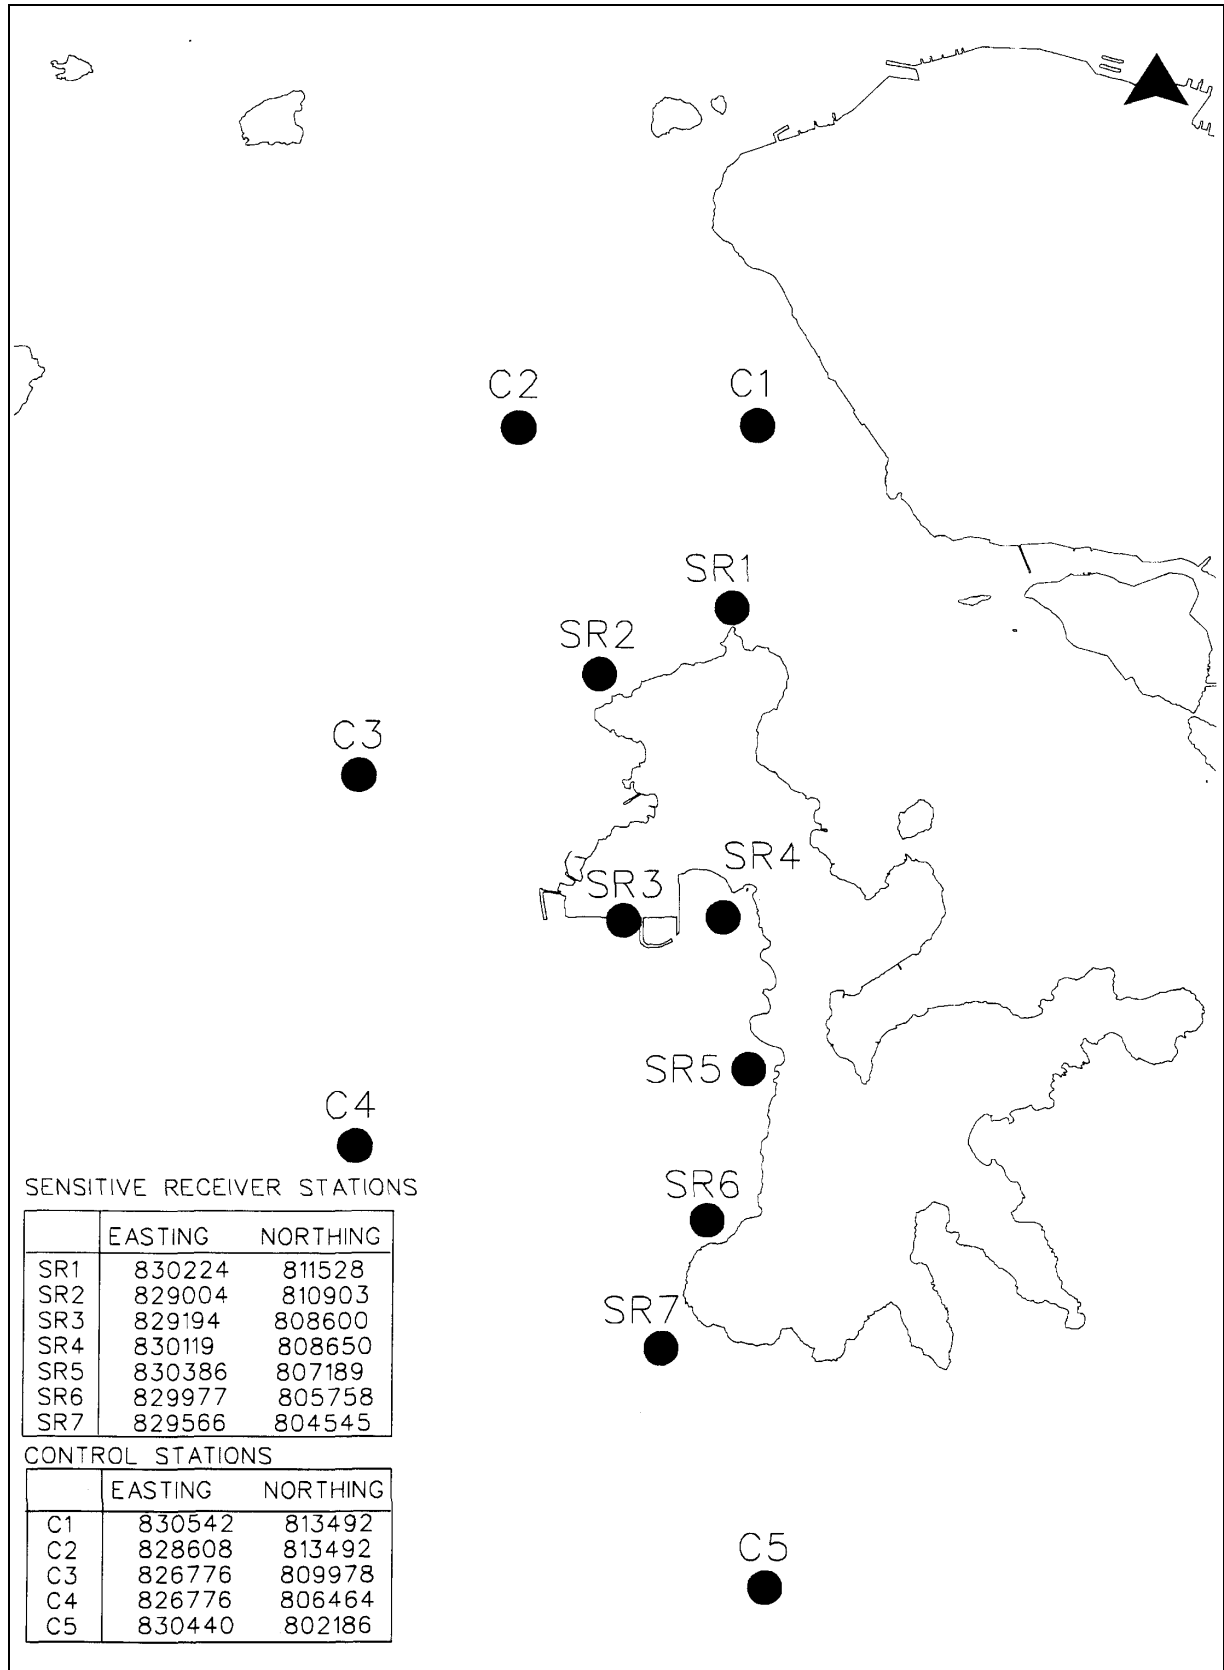
Figure 4.1 Location of Water Quality Monitoring Stations

A total of 12 water quality monitoring locations were selected. 7 Sensitive Receiver (SR) stations were chosen on the basis of their proximity to the construction site, 5 Marine Control stations (C) as recommended in the EIA were selected to facilitate comparison of the water quality of the SR stations with ambient water quality conditions. Table 4.1 describes the locations of these monitoring stations. Their locations are shown in Figure 4.1.

1. Due to the construction programme, the monitoring location SR3 was slightly shifted since the monitoring on 16th April 2001. EPD has verbally been informed of the shift of the monitoring location.
