This is the tenth monthly Environmental Monitoring and Audit (EM&A) report for the Project “Construction of Lamma Power Station Extension” prepared by the Environmental Team (ET). This report presents the results of impact monitoring on air quality, noise and marine water quality for the said project in January 2002.

This report summarizes the environmental monitoring and audit work for the Project for the month of January 2002.

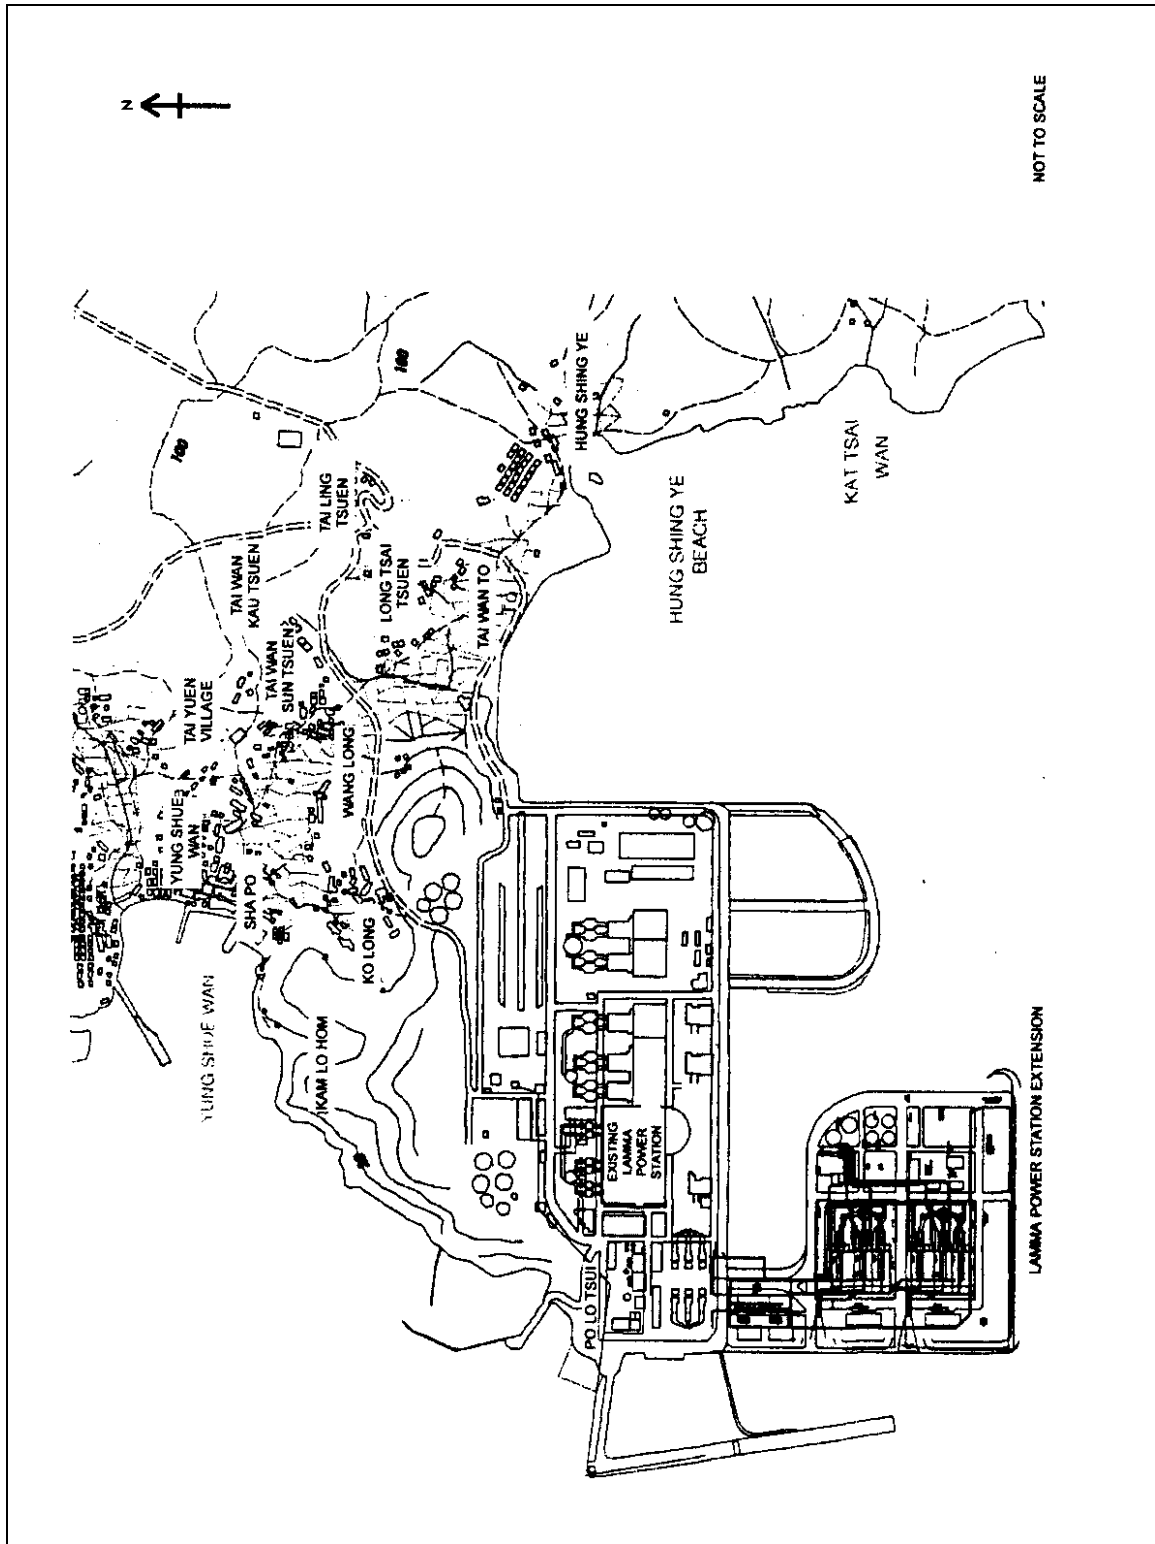
Figure 1.1 Layout of Work Site

Construction activities undertaken during the reporting month were placing of drainage layer, construction of seawall and sand filling. A Layout Plan for the Project is shown in Figure 1.1.

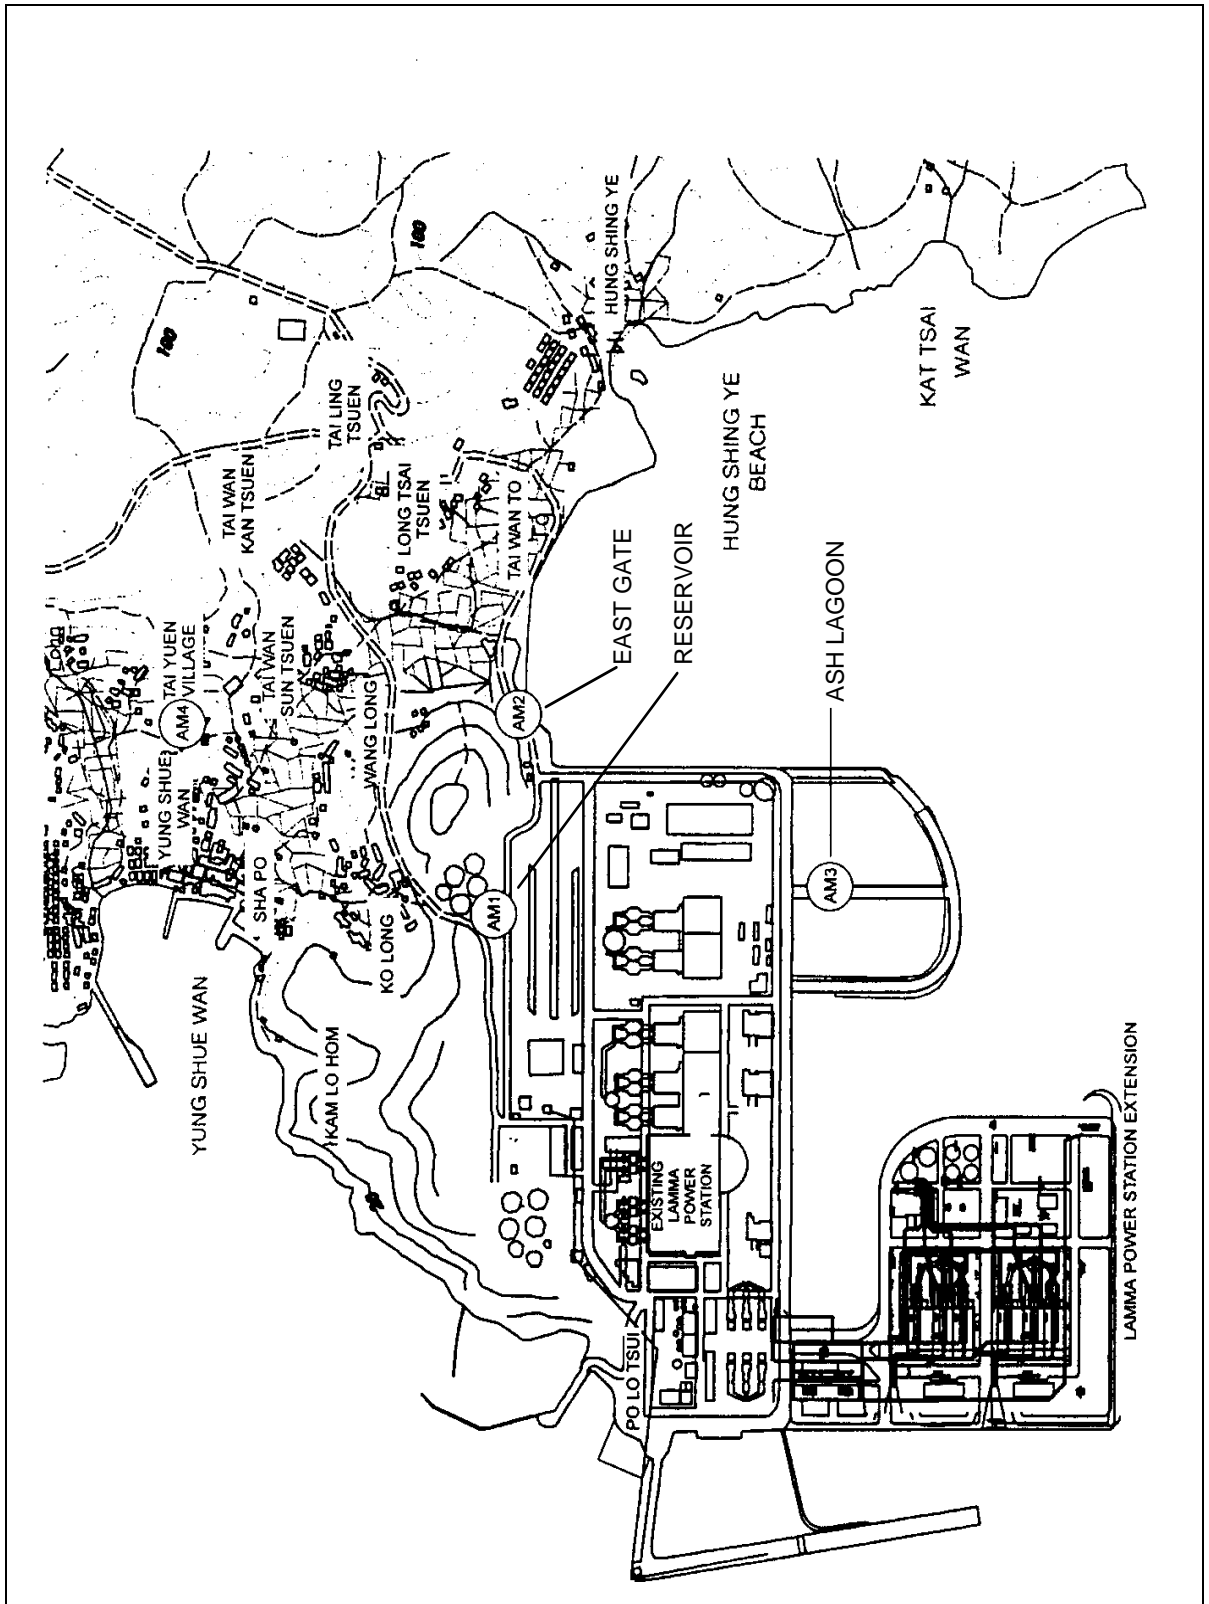
Figure 2.1 Location of Air Quality Monitoring Stations

Three dust monitoring locations were selected for 1-hour TSP sampling (AM1, AM2 & AM3) while four monitoring locations were selected for 24-hour TSP sampling (AM1, AM2, AM3 and AM4). Table 2.1 tabulates the monitoring stations. The locations of the monitoring stations are shown in Figure 2.1.

Location I.D.	Description
AM1	Reservoir
AM2	East Gate
AM3	Ash Lagoon
AM4	Tai Yuen Village

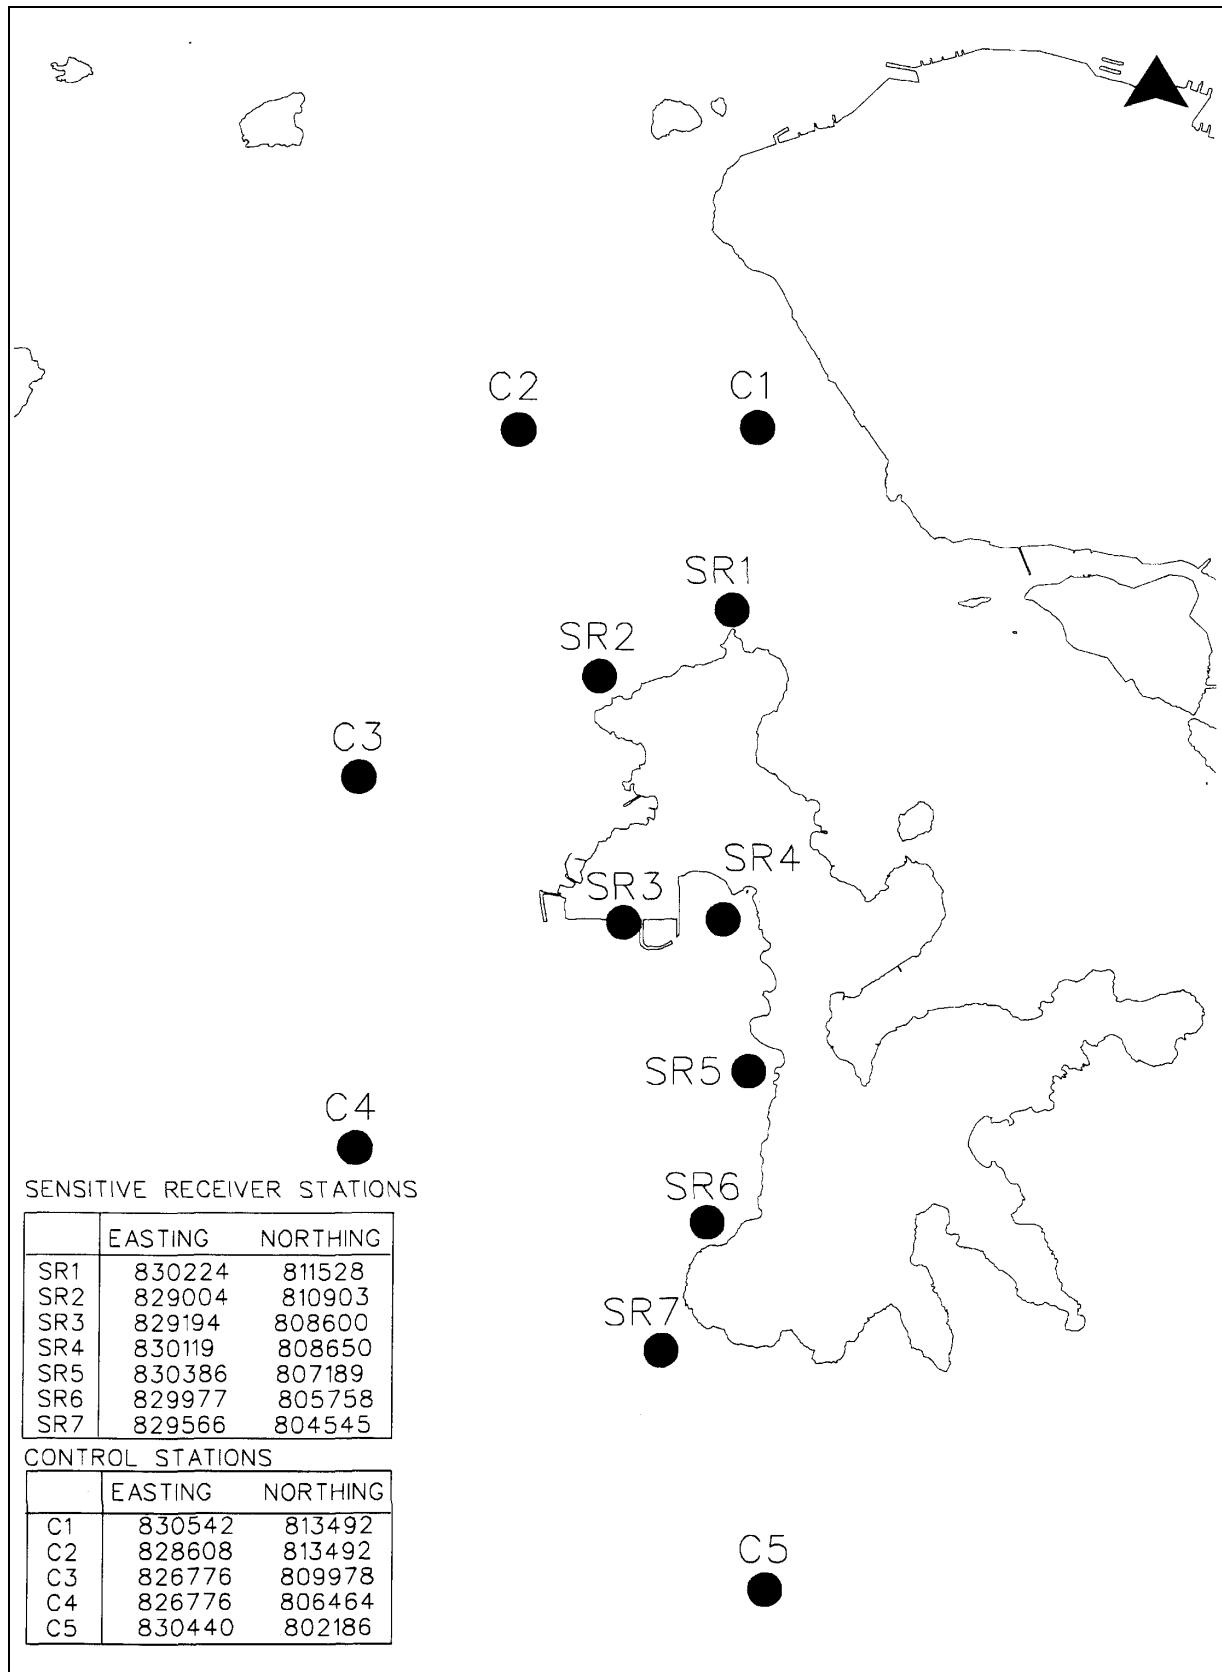
Figure 4.1 Location of Water Quality Monitoring Stations

A total of 12 water quality monitoring locations were selected. 7 Sensitive Receiver (SR) stations were chosen on the basis of their proximity to the construction site, 5 Marine Control stations (C) as recommended in the EIA were selected to facilitate comparison of the water quality of the SR stations with ambient water quality conditions. Table 4.1 describes the locations of these monitoring stations. Their locations are shown in Figure 4.1.

1. Due to the construction programme, the monitoring location SR3 was slightly shifted since the monitoring on 16th April 2001. EPD has verbally been informed of the shift of the monitoring location.
